Fracturing Under Buildings and other delicate work

FRx, Inc.
P.O. Box 498292
Cincinnati, OH
45249-8292

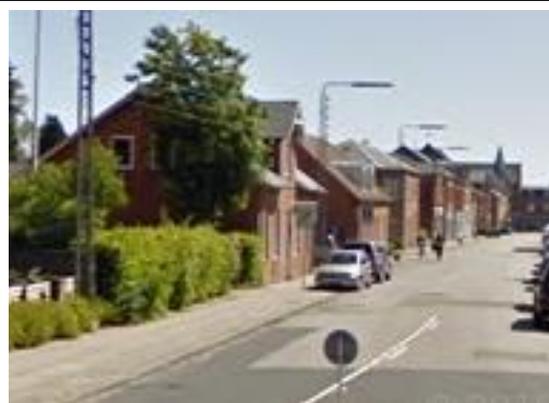
Red brick buildings along Vestergad Street, Haslev, date from the 19th century and currently are used for shops and residences. Neither structural nor cosmetic damage were allowed.

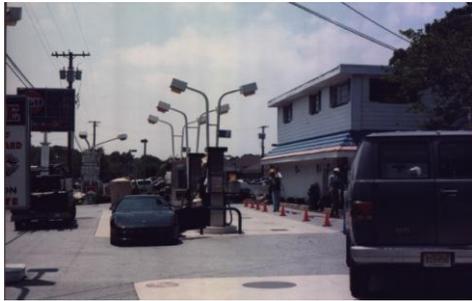
treatments. Some of the work was performed by cutting through the concrete floor of the building. Uplift was monitored by surveying techniques. This building, which was of light construction, was elevated by the fractures. No damage was realized in the structure or large plate-glass windows. Operation of the facility was not disrupted by the work, although pedestrian
